AFWAL-TR-82-4029

RAIN EROSION EVALUATION AND ANALYSIS OF  
SELECTED COATED MONOLITHIC POLYCARBONATE  
TRANSPARENCY MATERIALS

May 1982

Final Report for Period July 1980 - December 1981

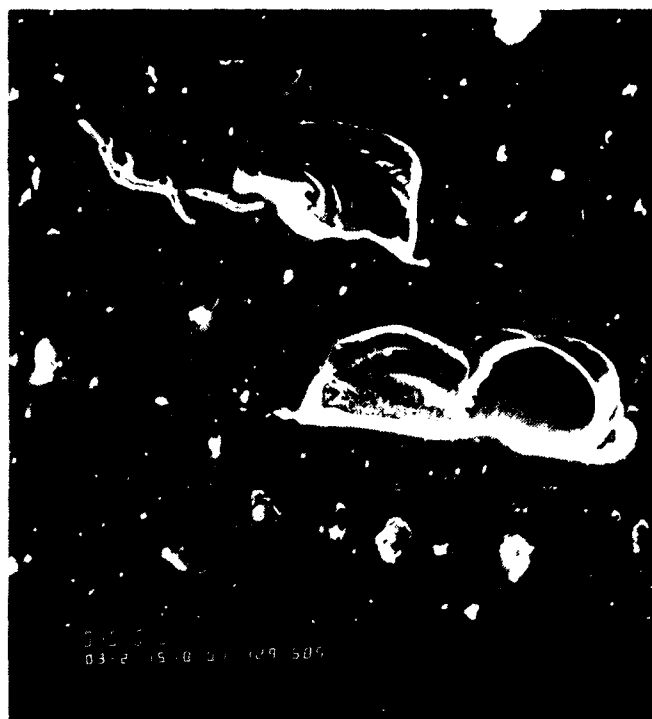
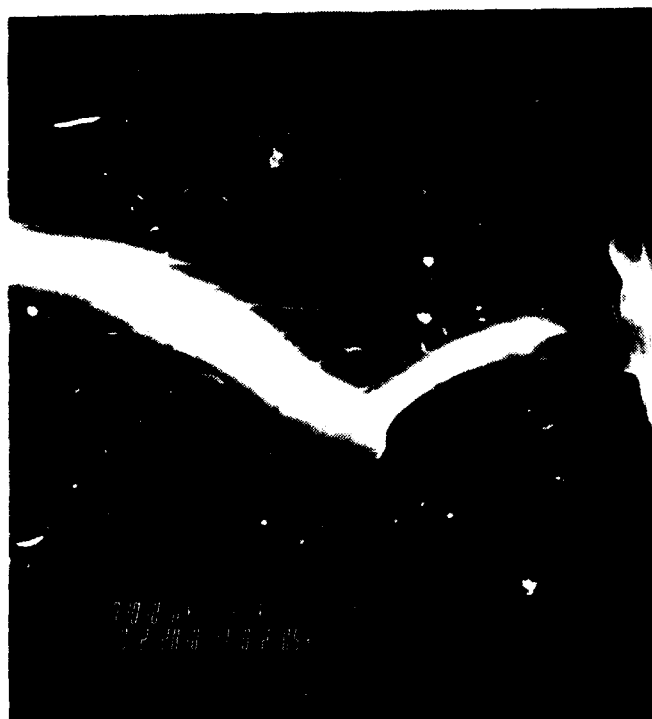
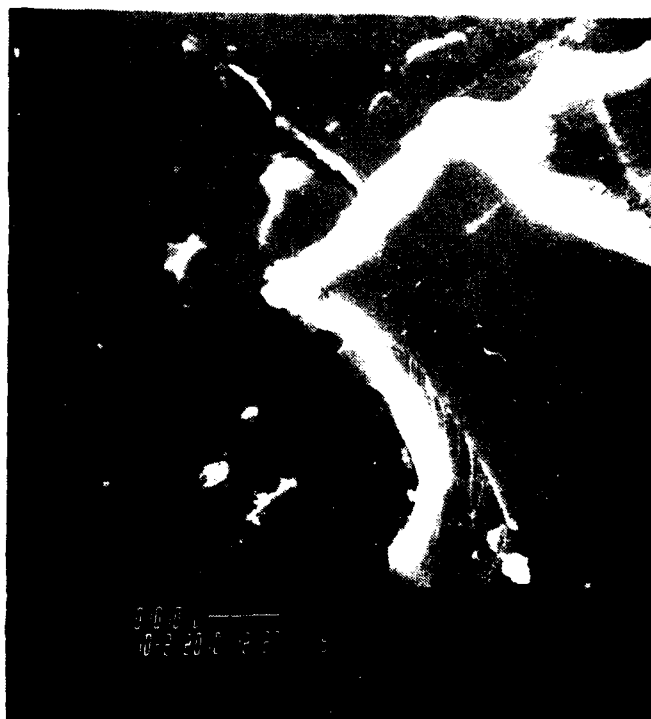
Figure B-1. Vendor P Coated Polycarbonate (No UV Exposure).

Exposure of the Vendor P non-UV exposed specimen to the previously described rain erosion test conditions resulted in coating surface damage as shown in Figure B-1. Short term exposure to rainfield conditions led to formation of localized defects in the coating surfaces up to 10 microns in diameter as shown in Figure B-1A. Further exposure to the rainfield led to the development of pits up to 30 microns in diameter at these localized damage sites and subsequently to localized coating removal (Figure B-1B). Continued exposures of five and 15 minutes to rainfield conditions resulted in substantial coating removal without introducing damage in the monolithic polycarbonate substrates as shown in Figures B-1C and B-1D, respectively.

The propagation stage of the rain erosion process, affecting the surface coatings, occurred through the joining of the local damage events as depicted in Figure B-1B and B-2A. Continuation of the damage "growth" process of the local events resulted in the coating removal of large areas a few hundred microns in size, and subsequently from the entire area of the test specimens exposed to rainfield conditions. The results of this propagation process are clearly shown in Figure B-3A as well as in Figures B-10A and B-10B. Coating removal through the propagation stage correlated with the high rate of coating removal as shown in the S-type kinetic curves. Whenever the propagation stage of uniting local erosion events stopped, no general erosion damage, i.e. coating removal, occurred and the coating surface remained fundamentally undamaged as observed in the Vendor B materials (Figures B-8A, B-9A, and B-9D). The observation that no advanced propagation stage occurred in the Vendor B material was also reflected in the kinetic curves, where the amount of coating material removal was essentially insignificant.

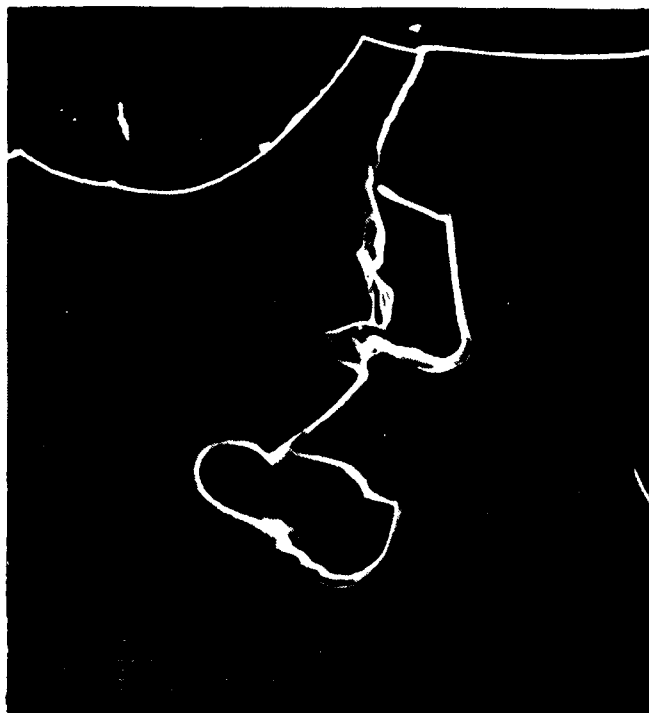
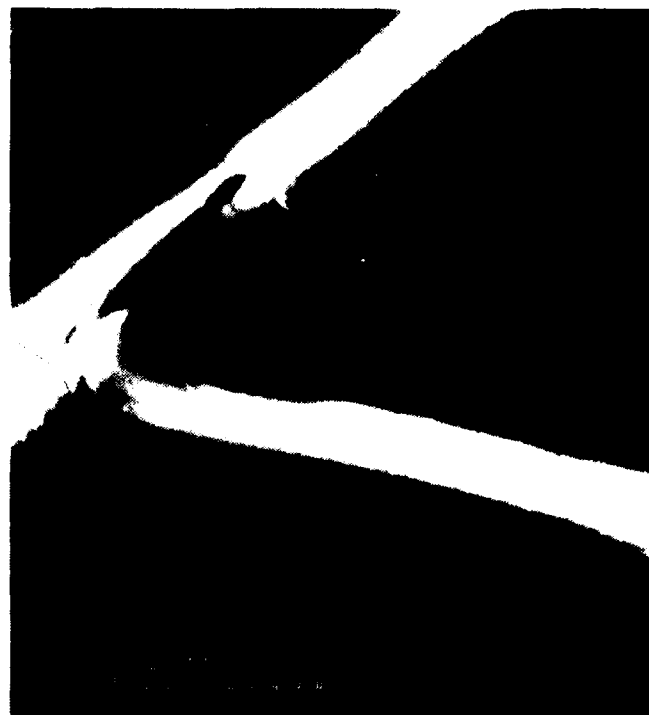
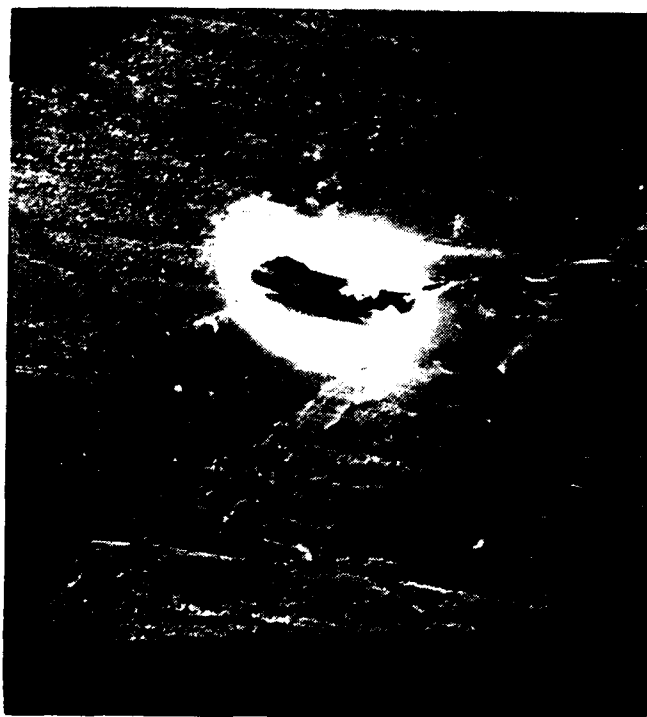
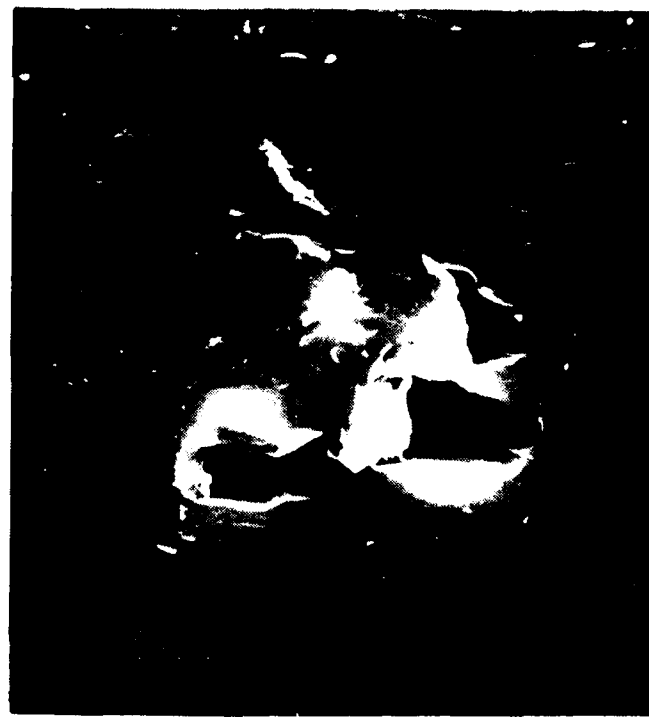
Figure B-2. Vendor P Coated Polycarbonate (1 Yr UV Exposure).

Two minutes exposure to rainfield conditions of the Vendor P one-year UV exposed specimens resulted in typical coating damage and removal, and these specimens are shown in Figures B-2A and B-2B. Further exposure to rainfield conditions resulted in progressive coating removal as well as introducing localized cratering of about 10 microns in diameter in the monolithic polycarbonate substrate as can be seen in Figures B-2C and B-2D.

Vendor A coating can be construed to be more ductile than the Vendor P coating. This can be deduced by comparing Figures B-5A and B-5B (where coating foldback was possible due to high coating ductility) with Figure B-2A (where coating brittleness is demonstrated by the formation of sharp boundaries and cracks in the zones of removed coating). Vendor A coating, being more ductile than the Vendor P coating, could absorb more of the rain droplet impact energy and still remain in contact with the polycarbonate substrate. This resulted in a longer incubation period as well as a decreased coating removal rate as compared to the Vendor P coating.

exposure to accelerated UV weathering caused an increased coating removal rate as well as introducing damage into the polycarbonate substrates of Vendor P and Vendor A. These observations are depicted in Figures B-2C, B-2D, B-3B, B-3C, and in Figures B-6A, B-6B, and B-6C. These findings suggest the probability that accelerated UV weathering affected the polycarbonate substrates. Polycarbonate is known to be sensitive to UV radiation, especially in the presence of moisture as reported in References 2, 4, and 5. Consequently, the resultant reduction in adhesion of the coatings to the polycarbonate substrates at their interface led to the decrease in incubation time as well as an increase in the rate of coating removal in the Vendor P and Vendor A materials.

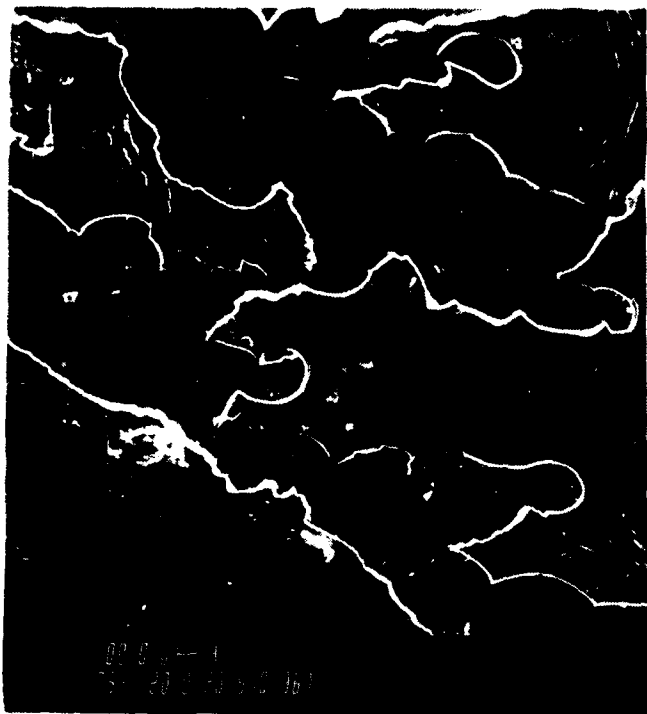
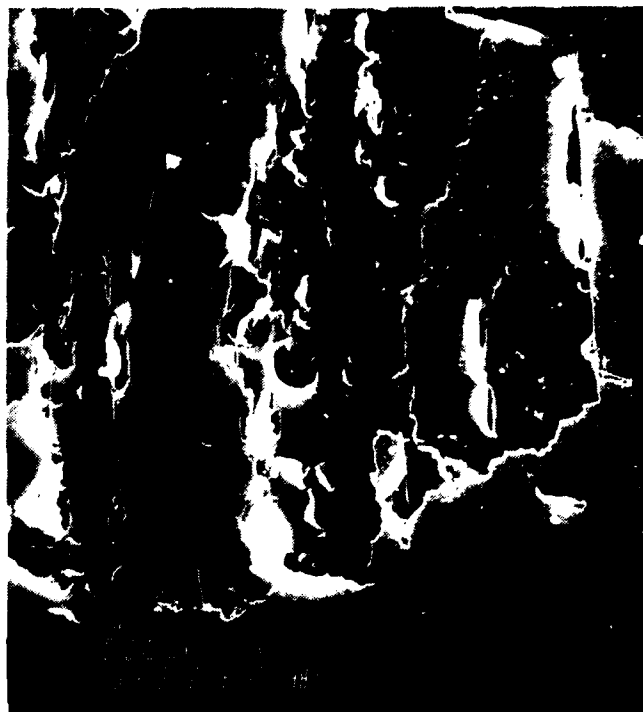
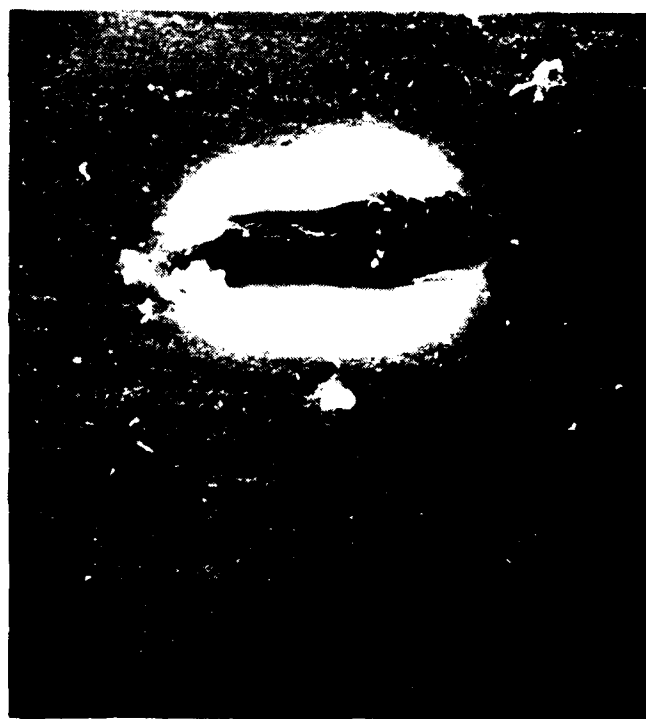
Figure B-3. Vendor P Coated Polycarbonate (3 Yr UV Exposure).

Typical surface damage of the Vendor P three-year UV exposed test specimens exposed to rainfield conditions is shown in Figure B-3. In Figure B-3A coating damage and removal from

the substrate after one minute of rainfield exposure is clearly shown. Coating damage and removal associated with damage to the polycarbonate substrate is revealed in the specimens exposed for two and 10 minutes of rainfield exposure as is shown in Figures B-3B and B-3C, respectively.

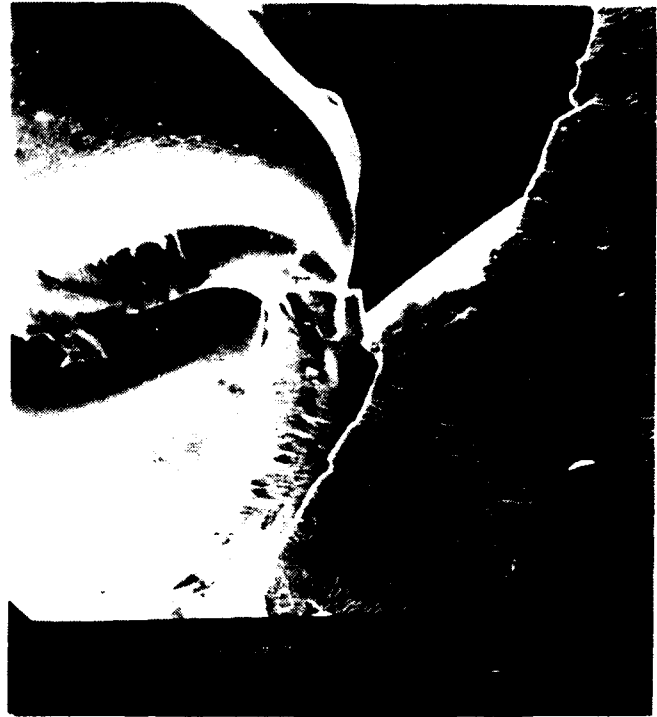
Figure B-5. Vendor A Coated Polycarbonate (1 Yr UV Exposure).

Figure B-5 shows the mode of surface damage obtained in Vendor A one-year UV treated test specimens after rainfield exposures up to 15 minutes. The damage is characterized by coating removal associated with coating separation and crack formation as shown in Figures B-5A and B-5B. Furthermore, noticeable streamlike lines were detected in the coating as indicated in Figure B-5B. This may be indicative of some phase (compositional or structural) changes within the substrate or the coating itself.

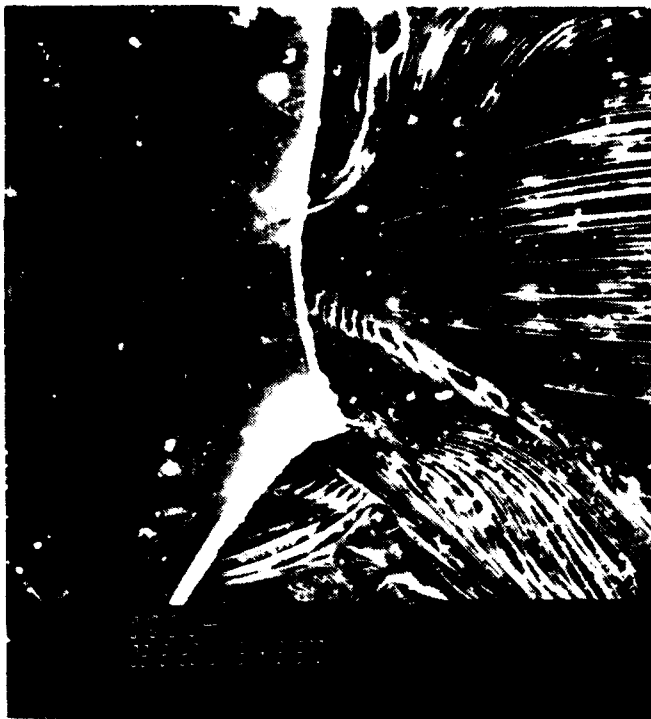
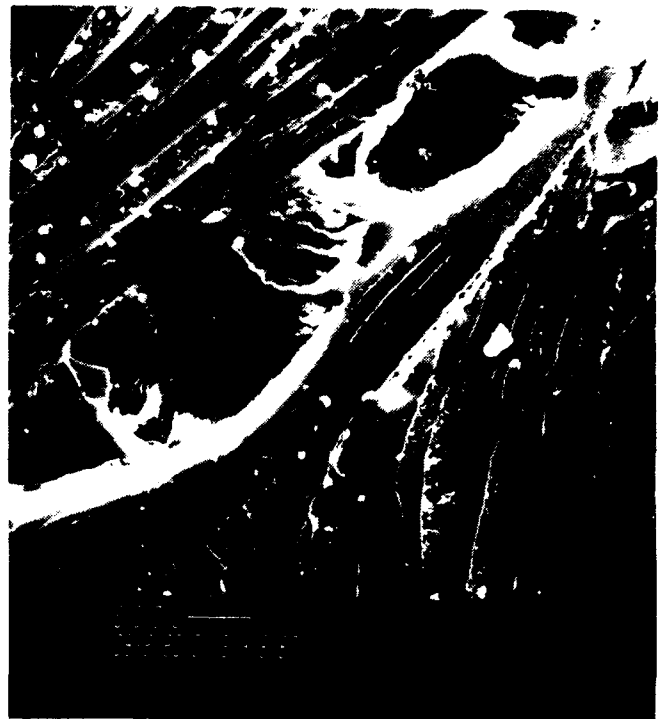
Figure B-6. Vendor A Coated Polycarbonate (3 Yr UV Exposure).

The Vendor A test specimens subjected to the equivalent of three years UV exposure and subsequently to rainfield exposure underwent surface damage as shown in Figure B-6. Coating material was removed as well as formation of elongated channels of 1 to 10 microns in width together with craters or pits up to 20 microns in diameter were detected in the polycarbonate substrate surface
